Manhole Inspection Summary

Manhole # S13MM_048MH

Insp Date: **3/12/09 2:48 PM**

Location Address: **2202 DUKELAND ST**

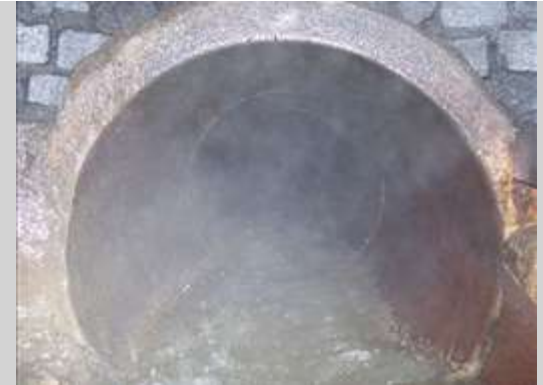
12 O'Clock Outflow

21 in. Circular Gravity Sewer
Pipe Out @ 12 O'Clock

Pipe Height: (in.) Direct
Pipe Material: **Clay** ☐ Pipe Lined
Invert Depth: **37.81** (ft.) Flow Characteristics: **Fast**
Deposits: ☒ None ☐ Mud ☐ Sludge ☐ Debris ☐ Grease
Silt Depth: (in.) Deposits Extent:
Infiltration: **None** Pipe Seal Cond: **Sound**

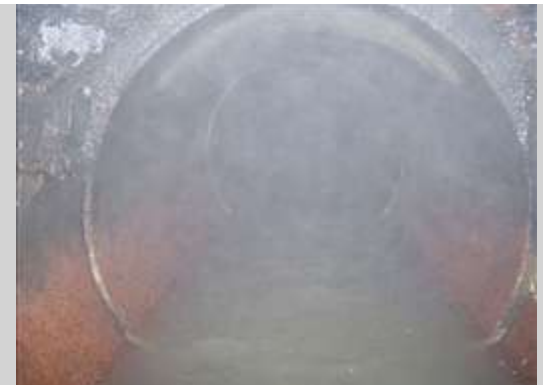
6 O'Clock Inflow

21 in. Circular Gravity Sewer
Pipe In @ 6 O'Clock

Pipe Height: (in.) Direct
Pipe Material: **Clay** ☐ Pipe Lined
Invert Depth: **37.52** (ft.) Flow Characteristics: **Fast**
Deposits: ☒ None ☐ Mud ☐ Sludge ☐ Debris ☐ Grease
Silt Depth: (in.) Deposits Extent:
Infiltration: **None** Pipe Seal Cond: **Sound**

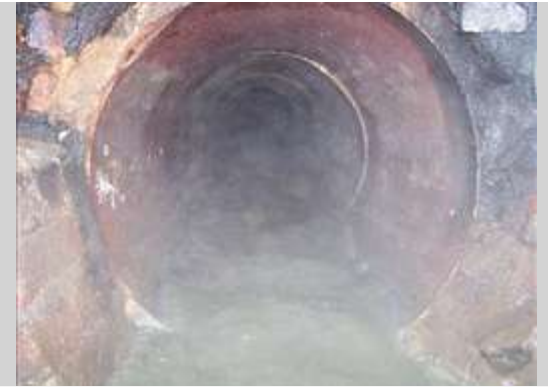
9 O'Clock Inflow

21 in. Circular Gravity Sewer

Pipe In @ 9 O'Clock

Infiltration: **None** Pipe Seal Cond: **Sound**
